## SAS Superstructure

### Daily Diary Report by Bid Item

Contract No.: 04-0120F4

04-0120F4  
04-SF-80-13.2/13.9  
Self-Anchored  
Suspension Bridge

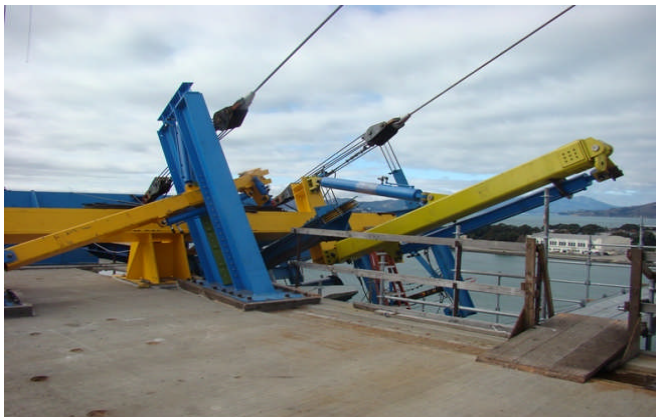
Floating and transfer arms for the secondary hauling system on the north end of the W2 cap beam.

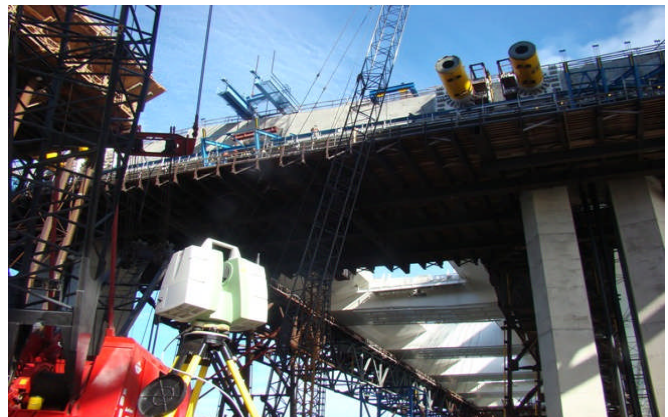
- Assisted the District 4 surveyors/scanners Robert Dolan and Juan Barahona with scanning the Hinge K pipe beams. All scanning views were taken from the ground holding control points TWL270 and ARMY2. The scanning operation began at 9:40am with sunny skies and an ambient temperature of 55F. The steel temperature at this time was 69F and was taken with a surface thermometer at PP1WN9. The scanning survey ended at 12:45pm with partly cloudy skies and an ambient temperature of 59F. The final steel temperature was 73F. There were a total of 4 points occupied to survey the W2 cap beam and Hinge K pipes from the ground. It should be noted that the Hinge K pipe beam protective covers were still over the end points to be surveyed. This issue also makes it difficult to scan the pipes. ABF is aware of the issue and is addressing other work at the W2 cap beam related to the cable secondary hauling system.

Setup of the Leica scanner on one occupied point where the W2 cap beam and Hinge K pipe beams were scanned.
